WL-TR-97-3093

**CORROSION AND FATIGUE STUDY
OF JSTARS AIRCRAFT**

Volume I

**NORTHROP GRUMMAN CORPORATION
MILITARY AIRCRAFT SYSTEM DIVISION
ONE HORNET WAY
EL SEGUNDO, CA 90245**

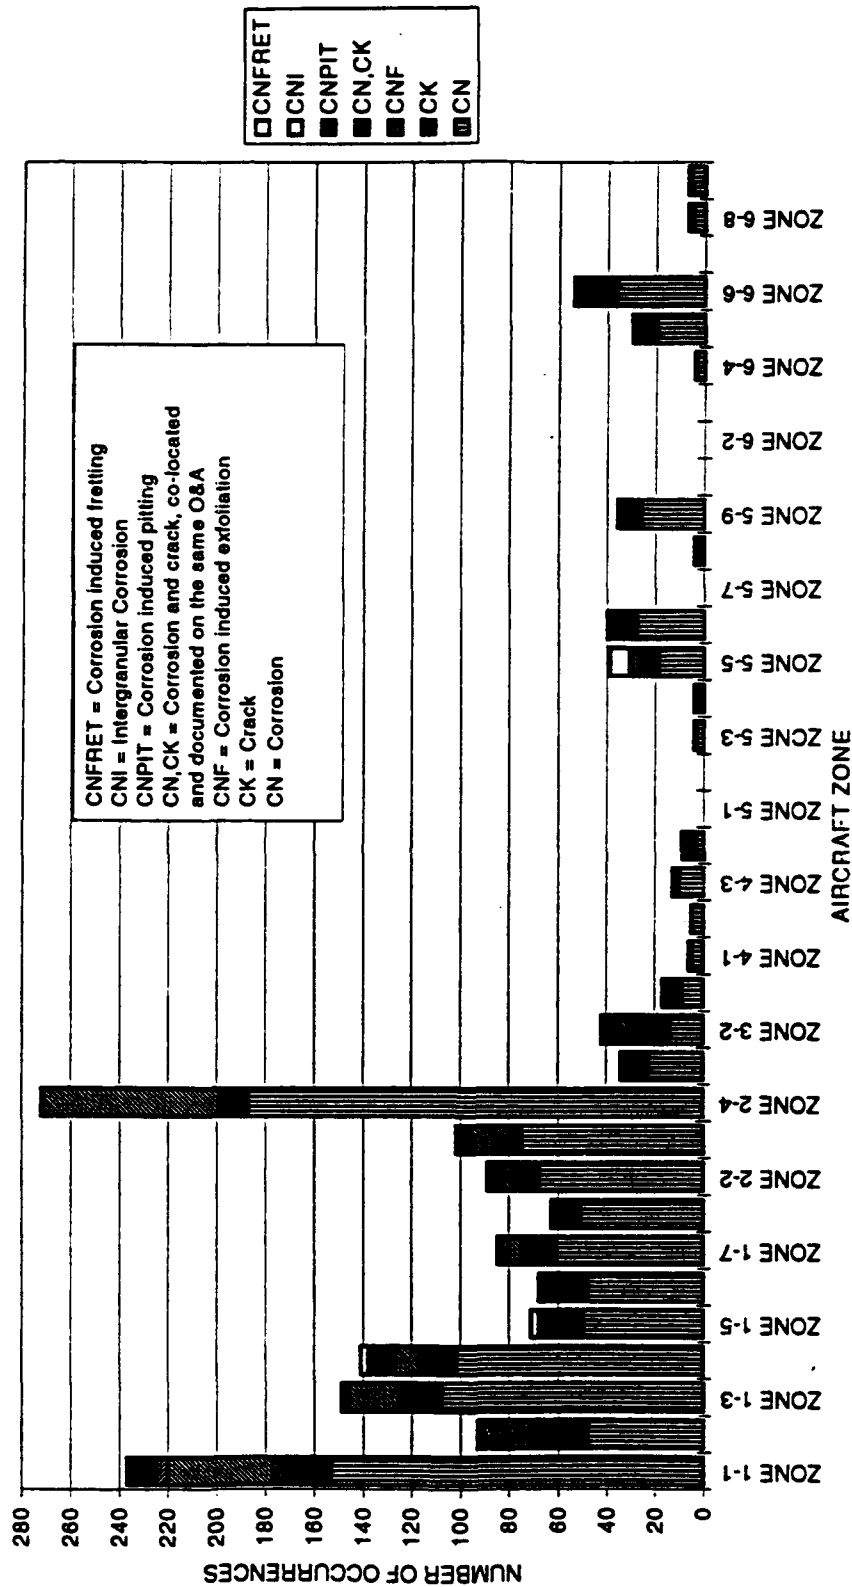
Figure 4.1 - Corrosion And Fatigue Damage Per Aircraft Zone On Joint STARS Aircraft P3 And P4

The areas of highest damage on the fuselage are in the following zones:

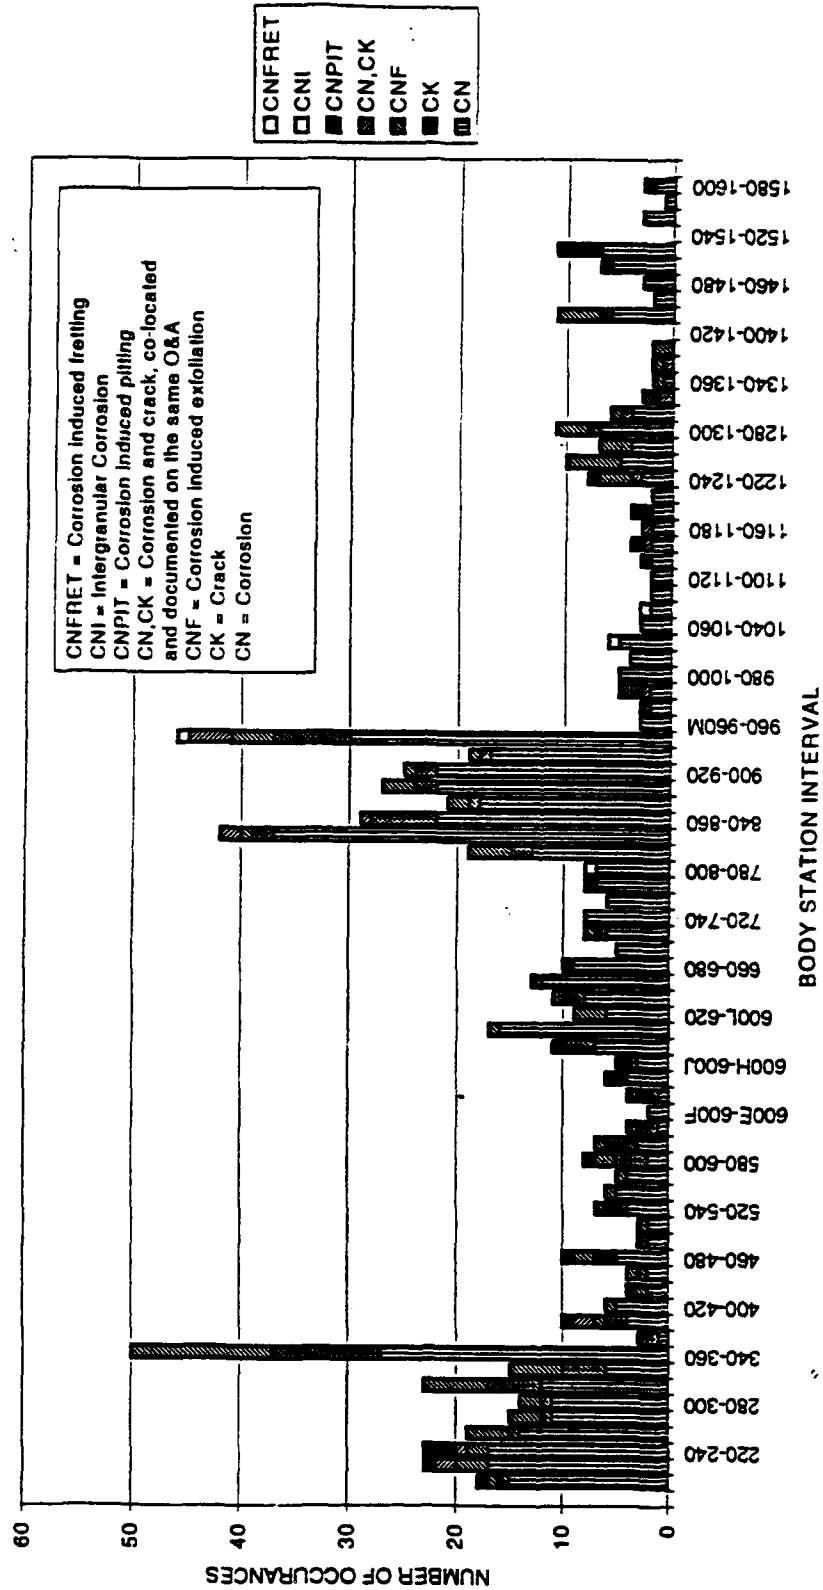
Figure 4.5 - Corrosion And Fatigue Damage On Internal Fuselage Structures Per 20 Inch Fuselage Segment On Joint STARS Aircraft P3 And P4

Figure 4.5 presents a higher resolution summary of the areas of damage on the internal fuselage structures. The aircraft fuselage is characterized by frame locations, which are spaced at 20 inch intervals. The high end of the segment coincides with the frame, when applicable (i.e. segment 420-440 would include the frame located at BS 440 but would not include the frame at BS 420). Aircraft zones are ignored. This analysis highlights specific areas exhibiting elevated levels of corrosion and fatigue damage. These areas are BS 200 to BS 360, BS 600K to BS 960, BS 1240 to BS 1320 and BS 1440 to BS 1520.

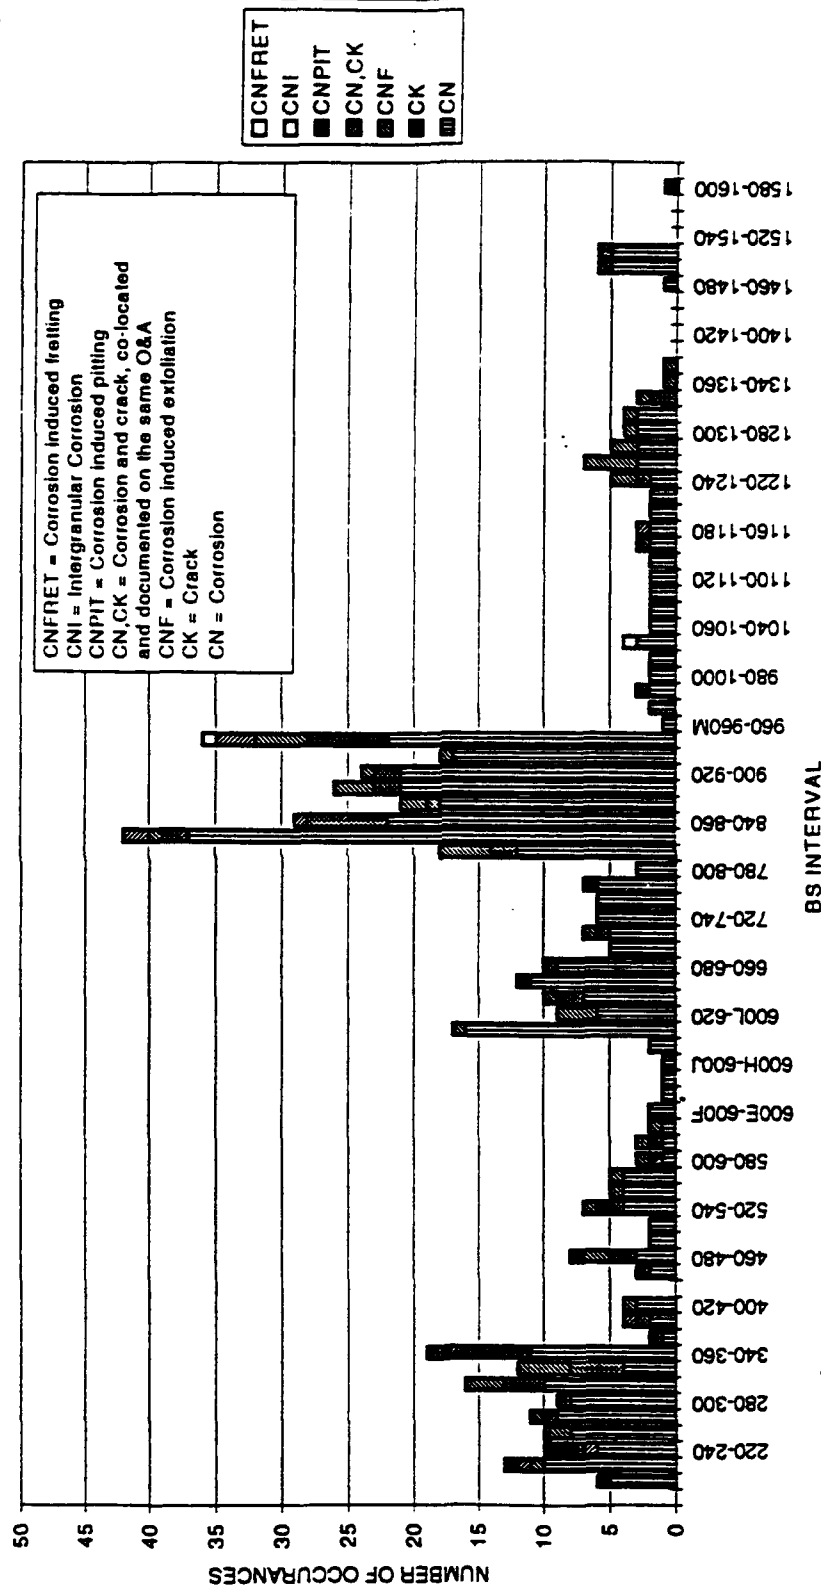
Figure 4.7 - Corrosion And Fatigue Damage Not Specific To Existing Frames And Bulkheads Per 20 Inch Fuselage Segment On Joint STARS Aircraft P3 And P4.

The corrosion and fatigue damage located between BS 200 and BS 360 can be largely attributed to the nose landing gear wheel well. The frames in this area, as shown in Figure 4.6, have a slightly elevated level of damage in comparison to the rest of the aircraft. The notable exceptions are BS 344 and BS 360, which display increased flaw density. As shown in Figure 4.7, the majority of the flaws between BS 200 and BS 360 are not associated with specific frames. Rather, they are located in the inter-frame structures specific to the nose landing gear. The non frame specific damage sites in addition to the flaw density on frames 344 and 360 make the region between BS 200 and BS 360 in zone 1-1 the most severe corrosion and fatigue damage site for internal fuselage structures.

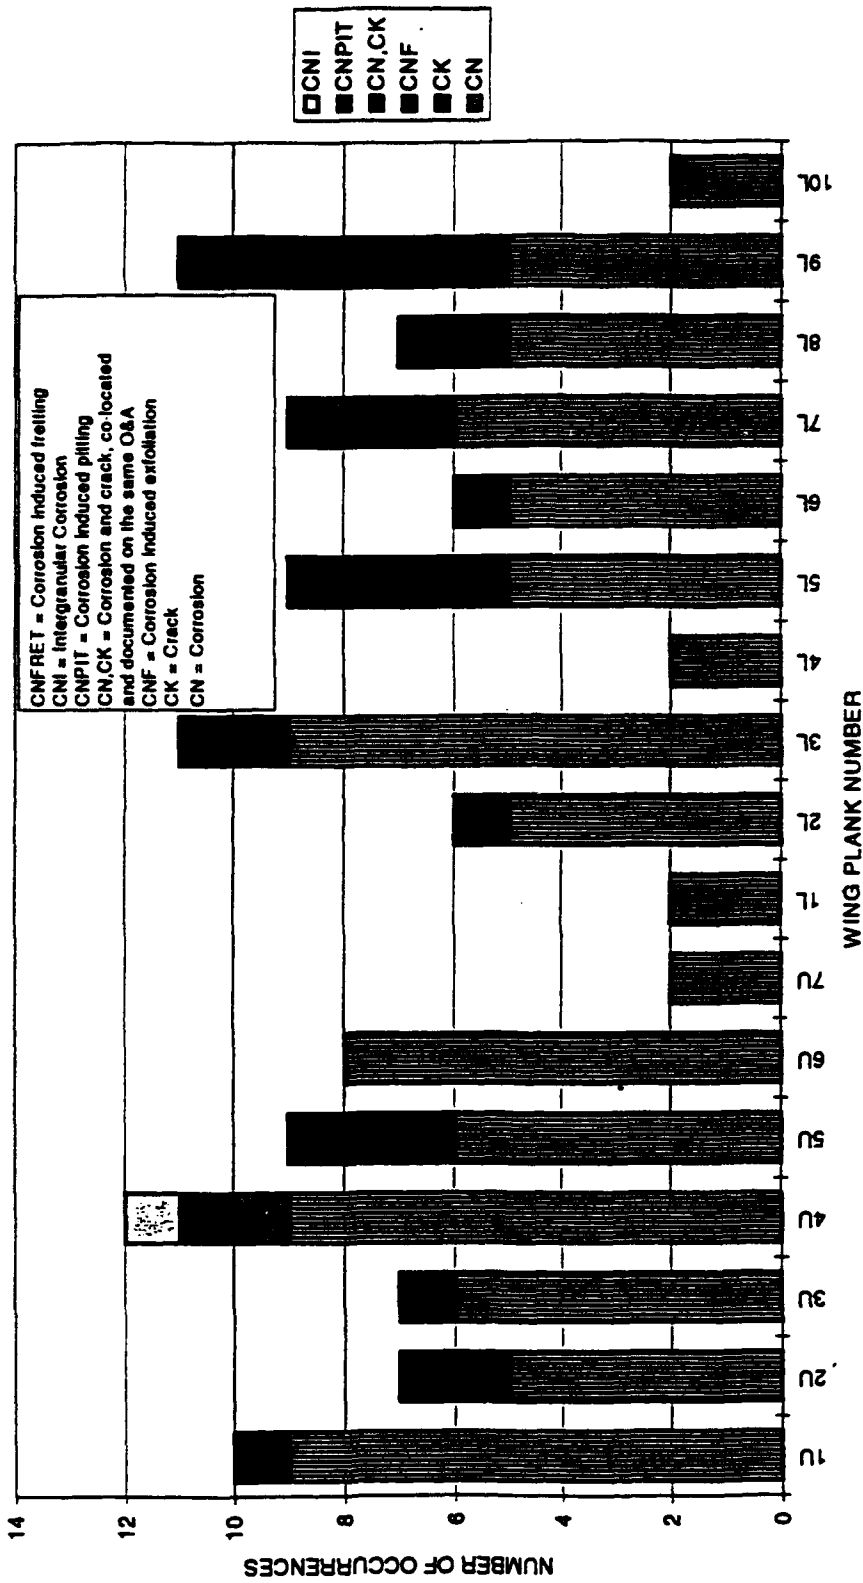
Figure 4.14 - Wing Plank Corrosion And Fatigue Damage Per Wing Plank Number On Joint STARS Aircraft P3 And P4.

A summary of the levels of damage specific to wing plank number is presented in Figure 4.14. This summary does not account for aircraft zones. The level of corrosion and fatigue damage sites remains fairly constant with respect to wing plank number except for wing planks 7 UPR, 1 LWR, 4 LWR and 10 LWR which exhibit relatively low levels of corrosion damage and the absence of fatigue damage.

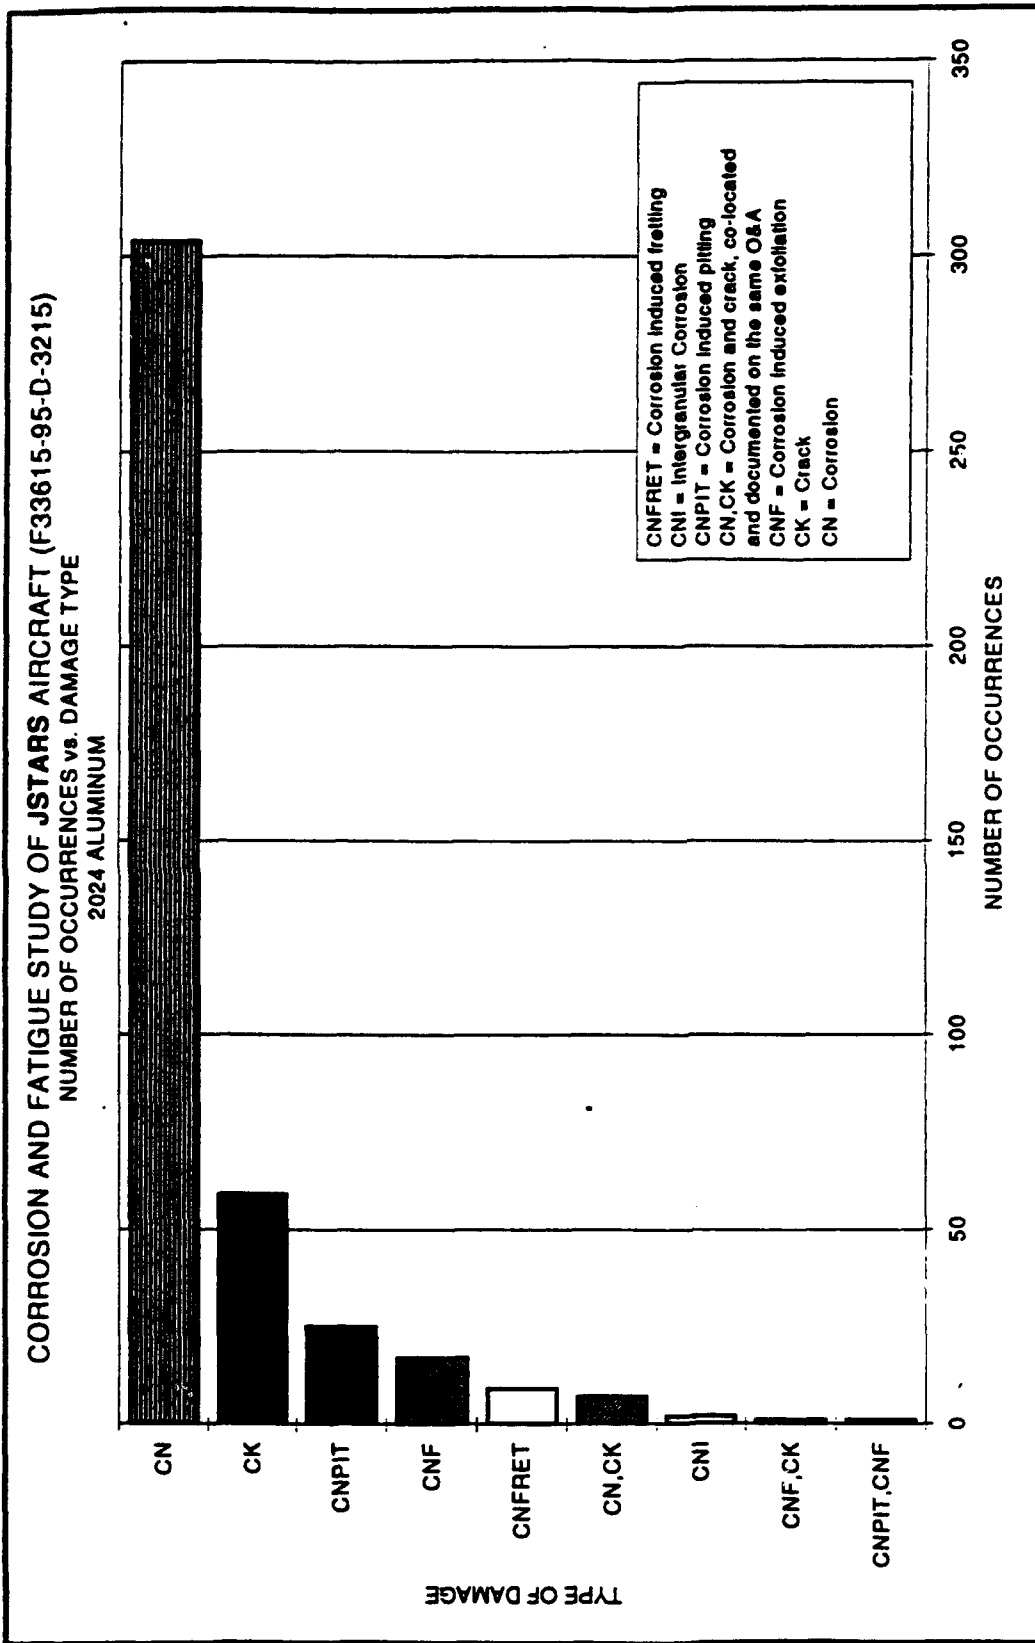
Segregation of the damaged elements by material and part form fails to highlight any significant trends. The two most prominent materials on the aircraft are 2024 and 7075 Aluminum. In both materials, the most prominent type of damage is simple corrosion, accounting for 71.5% of the damage sites identified as 2024 and 64% in 7075. This prevalence of corrosion damage is maintained, though at different percentages, regardless of part form. See Figure 4.16 and Figure 4.17.
